**National Endowment for the Humanities  
Sustaining Cultural Heritage Collections  
White Paper**

Project Title: Sustainable Microenvironment for Collections Storage

Grantee Institution: University of Colorado Museum of Natural History – Anthropology Section

Authored By: Christina Cain, CUMNH Anthropology Collections Manager and  
Don Reaville, Smith Seckman Reid, Inc.

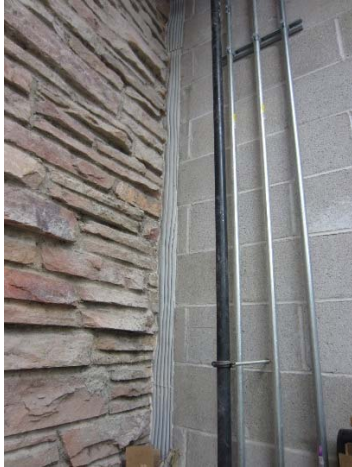
Before: Former Exterior Wall Meets 2010 Addition

While the ceiling in this space was insulated when built, the walls were cinderblock and contained no insulation. The exterior walls were outfitted with R13 EcoTouch® Pink® Fiberglas™ Insulation and gypsum sheetrock® panels. Finishing this space with insulation and drywall fit the budget of the implementation project and provided a good test case for envelope improvement. Monitoring of the space for pests and environmental fluctuation will be addressed in the Evaluation section below.

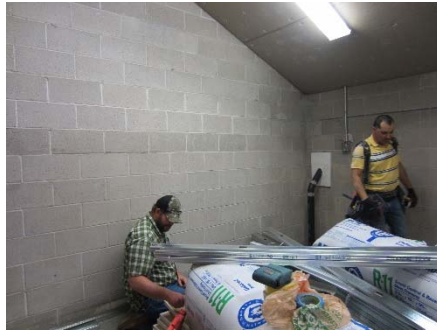
During Construction: East Wall Preparation of Insulation

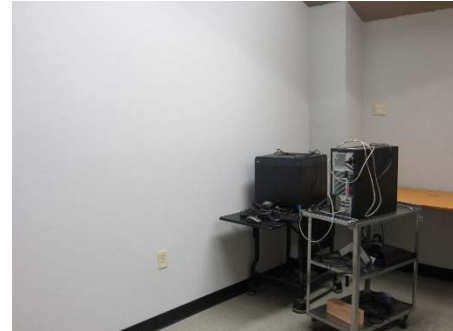
After: East Wall New Sheetrock Covers Insulation

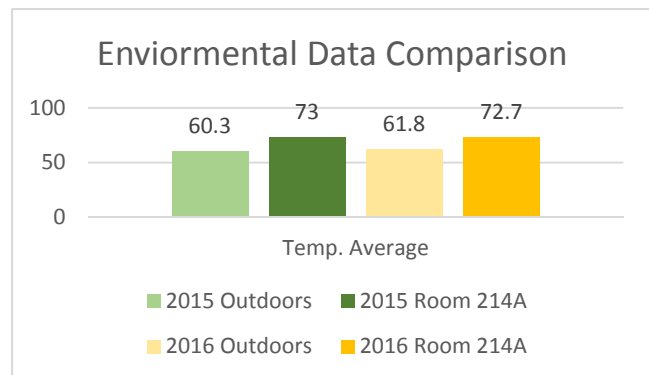
Evaluation of climate improvement was difficult given only two years of data. Other facts that must be taken into account include an evaporative cooler shutdown, due to a maintenance issue, in July 2016 that lasted for several weeks. In theory, this shut down should have caused a higher average temperature and potentially lower average RH for the building. Data comparisons between the relevant months from 2015 and 2016, however, show that while the average outdoor temperature was 1.5 degrees higher in 2016 than 2015, the indoor average temperature was .3 degrees cooler. Could this mean that the improvements are insulating the room, even if slightly? It is possible, but far more data is required to come to any conclusions.

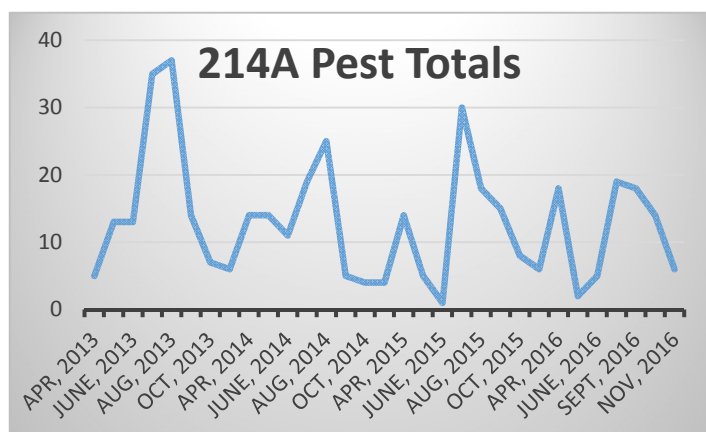
For pests, we evaluated the total number of insects found in the space over the relevant months from the implementation project until now and compared data from the same months from the last four years. Paying particular attention to the summer peaks, when pests are the most plentiful, we do see a lower number in total insects than the previous four years. While this could hint at success, there is not yet enough long-term data to draw any conclusions about the effectiveness of the

insulation barrier to pest activity. Continued monitoring will show more conclusive data from which to draw conclusions.

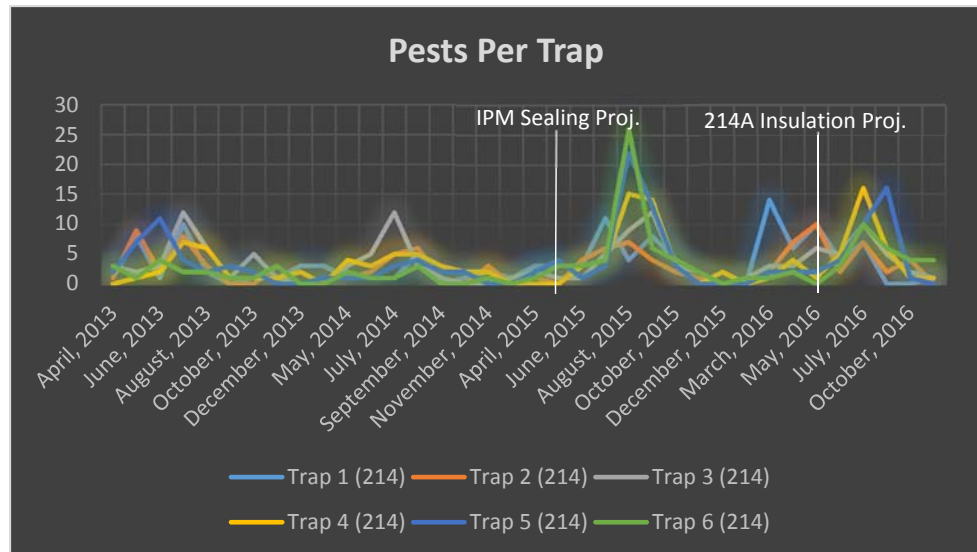
This project took place in May of 2015. Monitoring for pests is much the same as for room 214A. When examining data for the last two years, it appears overall pest numbers have gone down for most traps. However, when we further examined the last four years, numbers actually rose in 2015 and then came back down some in 2016. Is this a failure of the sealing project in some way? Additional study was required.

When we further examined the types of pests we were finding and those that increased in number, we find odd beetle larvae and clover mites are the only pests that increased, with all others decreasing.

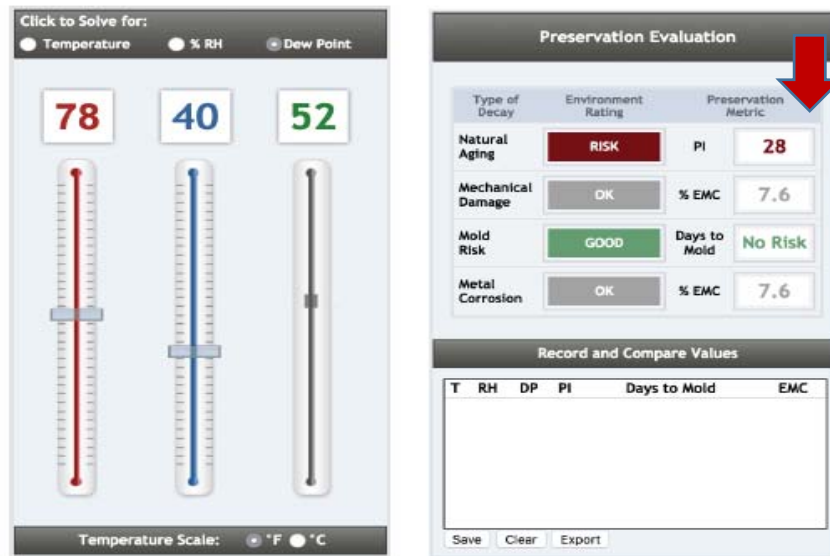
Current average summer conditions show a preservation index<sup>ii</sup> of only 28.

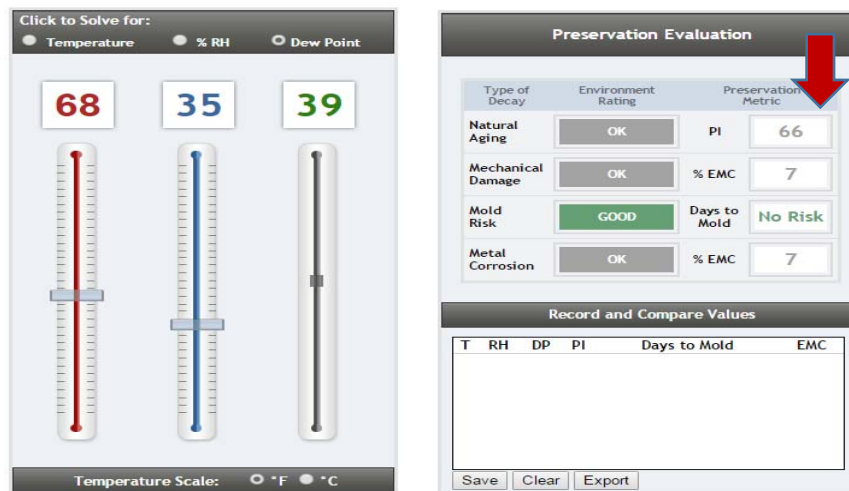
Summer Conditions

With new recommended and achievable set points that can be produced with the designed equipment, we can reach a preservation index of 66 in summer and 110 in the winter.

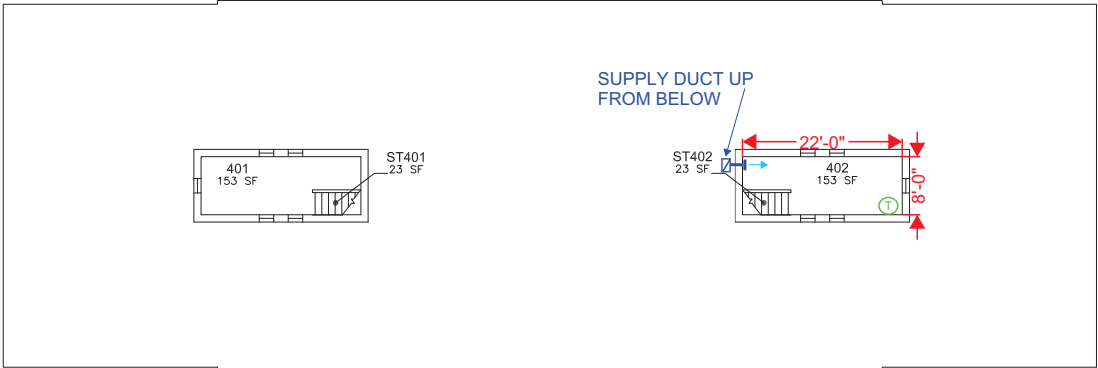
FOURTH FLOOR LEVEL

THE UNIT LOCATION AND DUCT ROUTING ARE SCHEMATIC IN NATURE WITH REGARD TO ROUTING. THEY ARE SHOWN TO CONVEY INTENT OF SYSTEM ZONING. ACTUAL DUCT ROUTING WILL BE DETERMINE LATER IN DESIGN BASED ON THOROUGH SITE INVESTIGATION AND STRUCTURAL EVALUATION FOR BUILDING WALL AND FLOOR PENETRATIONS.

A HORIZONTAL MOUNTED AHU IS SHOWN, HOWEVER A VERTICAL TYPE UNIT WILL BE EVALUATED AND CONSIDERED AS WELL, AND THE MORE DESIRABLE UNIT WILL BE CHOSEN WITH REGARD TO IMPACT ON FLOOR SPACE AND DUCT ROUTING.
